This spreadsheet performs screening level calculations to estimate the effect of peeling leaded paint on the average concentration of lead in yard soil
3322 Gilpin St.

Property ID: 177	Date: 8-18-05
Address: 3322 GILPIN STREET	Telephone #:
Owner:	CO Certification #: 12860
Inspector/Assessor:

LBP Assessment Results

SITE NAME: VASQUEZ BOULEVARD AND I-70

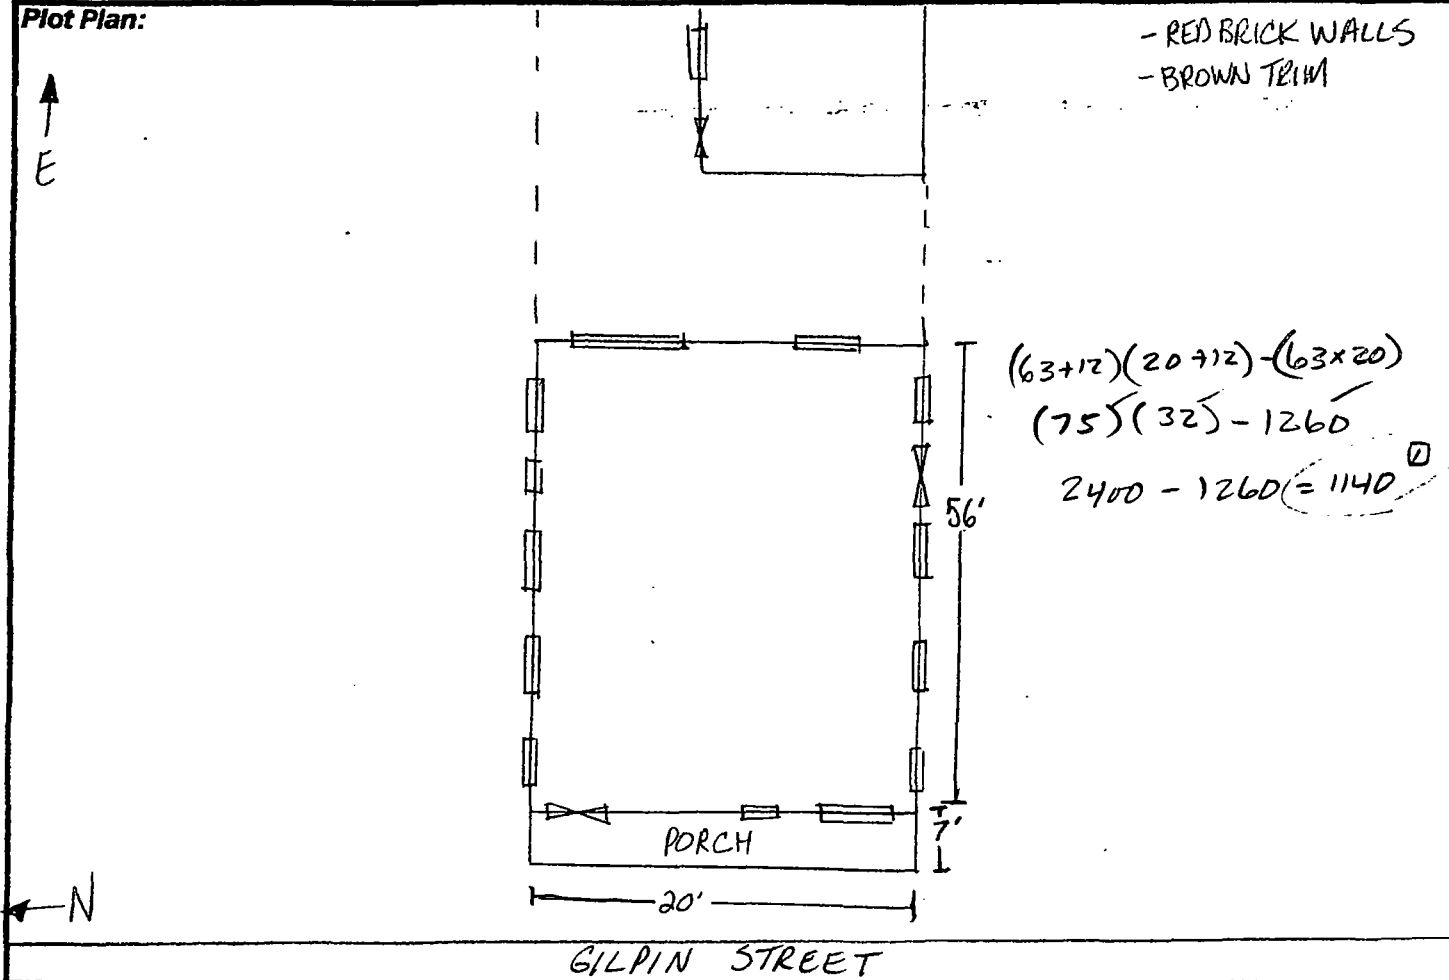
Plot Plan:

Window Trim/Fascia/Soffit				Patios/Decks/Porches			
Material	Area	Peel/Chip	XRF (Lead)	Material	Area	Peel/Chip	XRF (Lead)
WOOD	20' A	PEEL	14.2				
WOOD	41' A	PEEL	15.3	WOOD TRIM	34' A	PEEL	10.2
WOOD	—	CRACK	16.8				
WOOD	—	CRACK	40.8	WOOD CEILING	—	CRACK	7.4

Metal Trim/Gutters/Downspouts				Misc Structures/Garage/Fences			
Material	Area	Peel/Chip	XRF (Lead)	Material	Area	Peel/Chip	XRF (Lead)
				WOOD	—	—	6.9
METAL GUTTER	—	—	1.2
